Draft Environmental Assessment

Reconstruction of the Sauk River Road

Snohomish County, WA

FEMA-1499-DR-WA (Public Assistance)

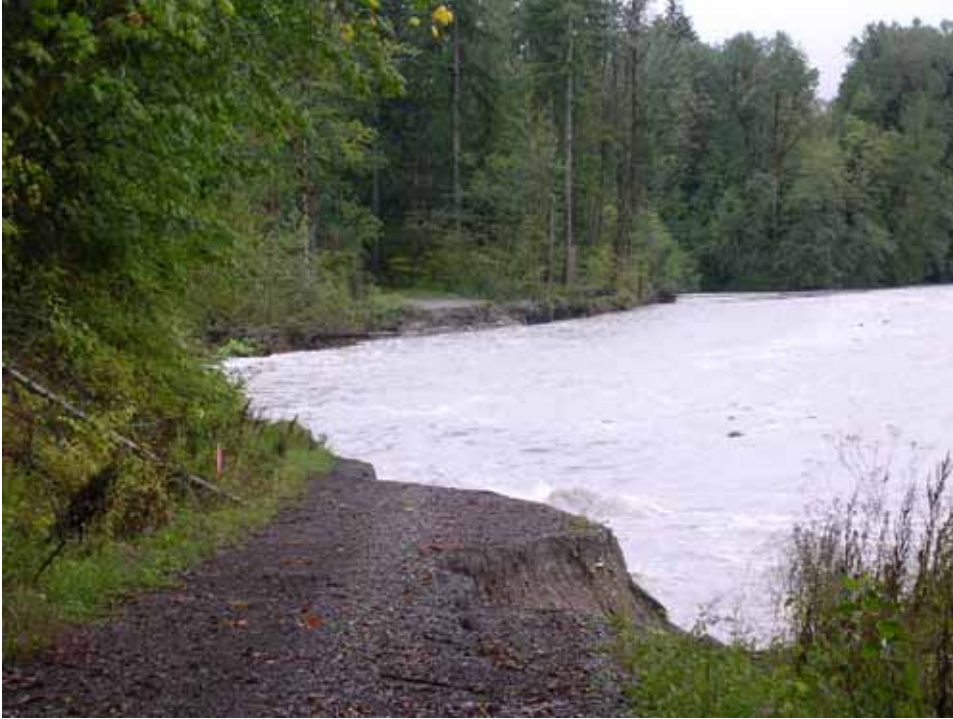
Photo 1. Sauk River Road washout from downstream end looking upstream.

The Sauk River Road washout is located at approximately River Mile (RM) 23, along the right bank (east) just outside the town of Darrington (Figure 1-1). The road washout is located about 0.5 mile from the intersection with Sauk Prairie Road (Photo 1). Adjacent land is owned by the Washington Department of Natural Resources (DNR). About 1,000 feet of road was removed from the flood.

Currently, residents must walk around and beyond the washout to reach their properties. Snohomish County installed a locked gate near the intersection with Sauk Prairie Road, and residents have vehicle access to the remaining road section. The road is barricaded with concrete blocks near the washout. Snohomish County also secured the area to protect life and property by clearing debris off the road, placing road barriers at the downstream end of the washout, and creating a small vehicle turn-around for the property owners at the end of the road.

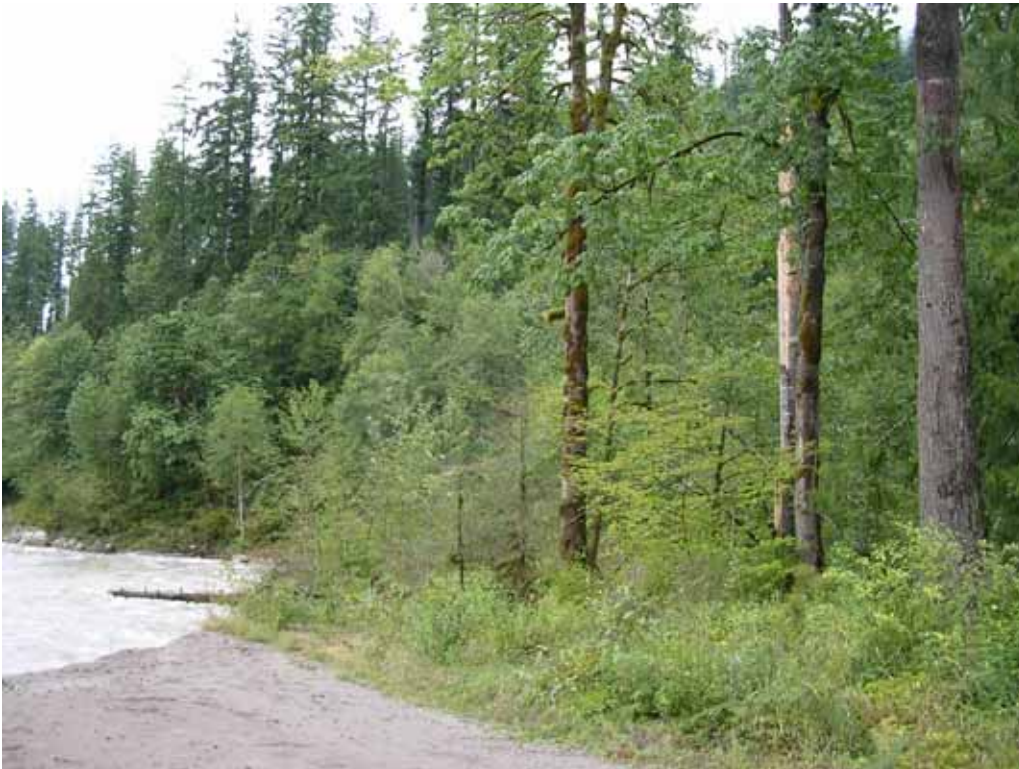
Photo 2. View from upstream end of washout looking downstream.
